C.PP. psigp. Aluminum Household Effects Shipping Container

"EVALUATION OF AN EXPERIMENTAL COLIAPSIBLE ALUMINUM HOUSEHOLD EFFECTS CONTAINER"

Engineering Report #2.2020254 29 December 1950 under Project No. NTOC3016

"ADDENDUM TO EVALUATION OF AN EXPERIMENTAL COLLAPSIBLE ALUMINUM HOUSEHOLD EFFECTS CONTAINER"

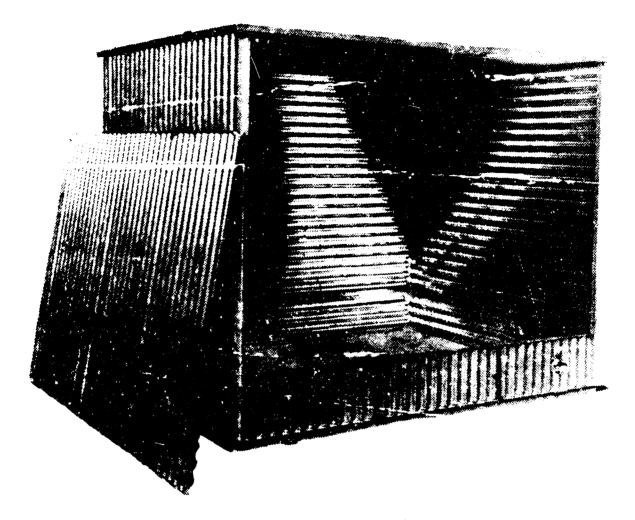
Photo Neg. No. USNSRDF 535-5

ASSECULED UNIT

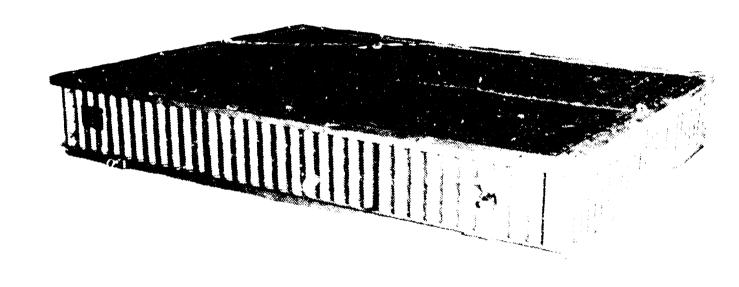
Photo Neg. No. USNSRDF 522-1

*NOCKDOWN UNIT
